Rig Visit Verification Report

Borgland Dolphin

AUDITEE
Dolphin Drilling
AUDIT NO.
EA-2020-9
APPROVAL

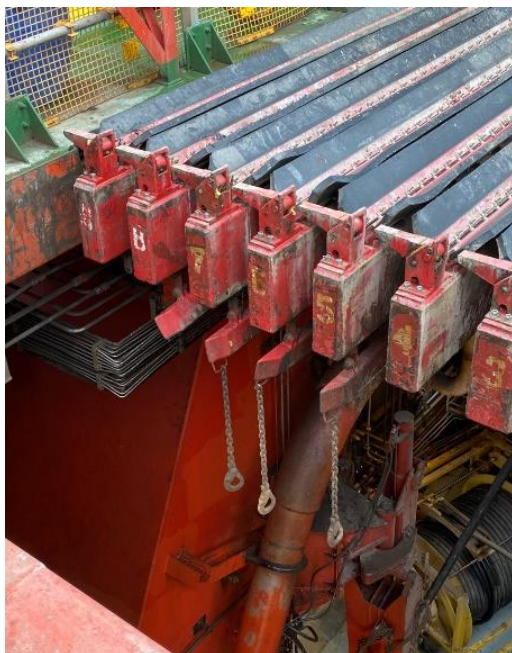
Figure 0-7: Fingerboard

Figure 0-7 shows chains shackles to secure pipes. The RIT were told that the chains were not used or maintained. Figure 0-8 shows potential dropped object, a mounting bracket for the hook was broken.

Classification:	Observation # 7
Title:	Potential Dropped Objects
Risk classification:	Medium
Description:	A mounting bracket for the hook on the fingerboard was broken. Chain schakles to secure pipes were not used or maintained.

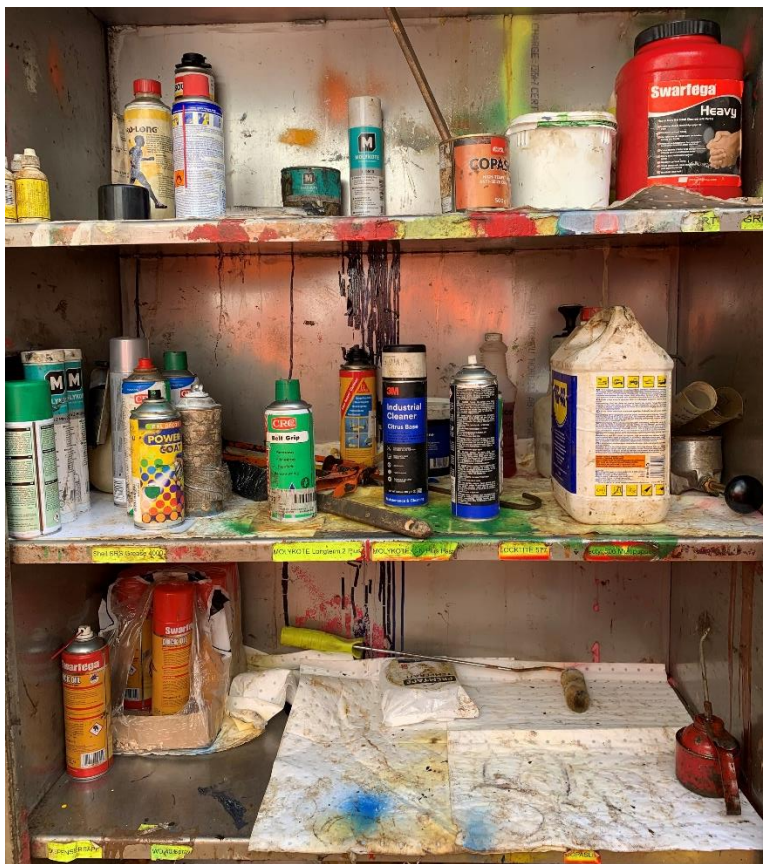
Figure 0-11: Good first impression with chemical tags

"RD-0231 Kjemikalieplassering Borgland Dolphin", describes storage areas onboard Borgland. There are several chemical lockers onboard, and the chemical locker on drill floor was checked. The first impression was good as some of chemicals had tags on where they should be placed, see Figure 0-11. However, when looking closer, the chemicals were not placed on the correct tag, Figure 0-12 It is recommended that all chemicals have tags and are placed where they belong to keep it organized. All chemical lockers shall also have marking signs, a list of which chemicals are in the locker and SDS nearby, see Figure 0-13 for correctly marked locker.

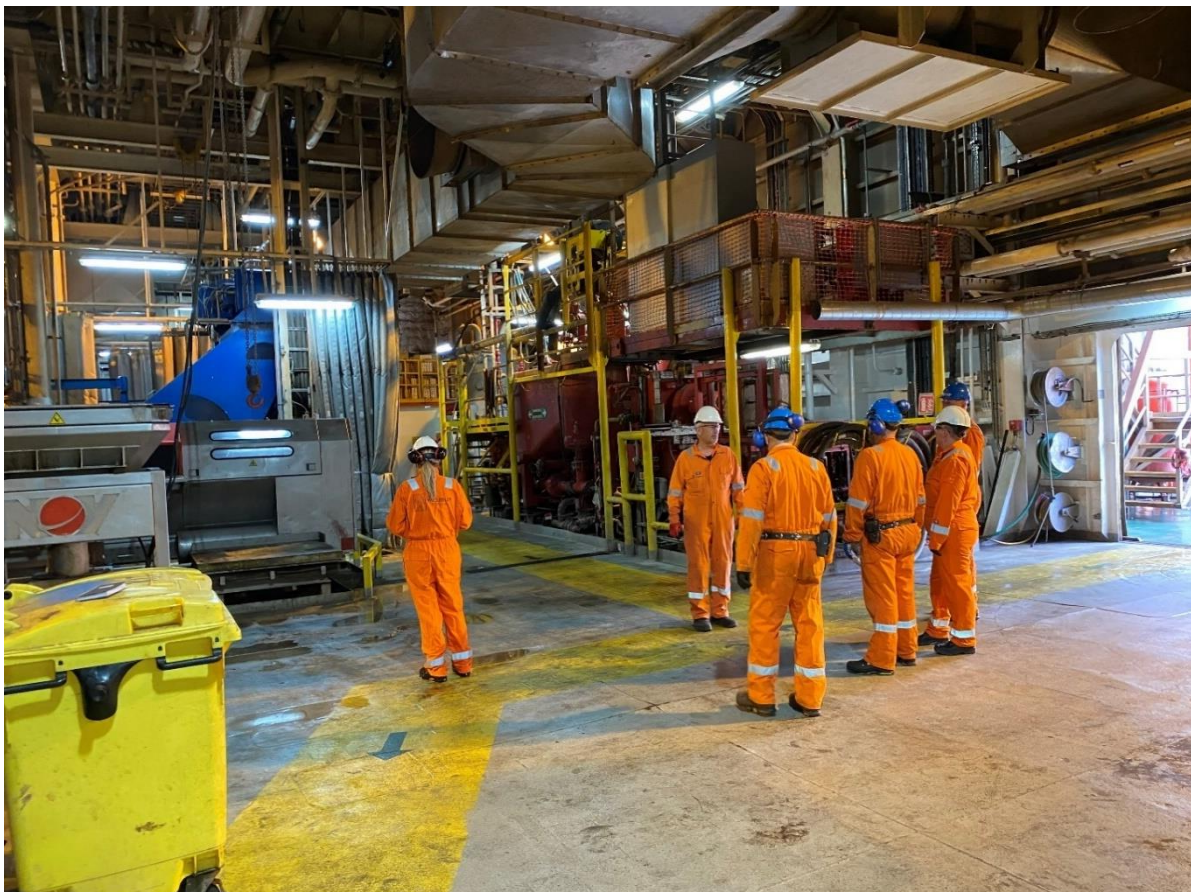
Figure 0-14: Sack store and mud pump room.

As the rig is currently at Feda and some suppliers are removed from the rig, the sack store was emptied for mud and cement chemicals (Figure 0-14). It is expected that service companies keep it tidy when storing chemicals and only approved chemicals are on the rig. This will be checked before start-up of operation.

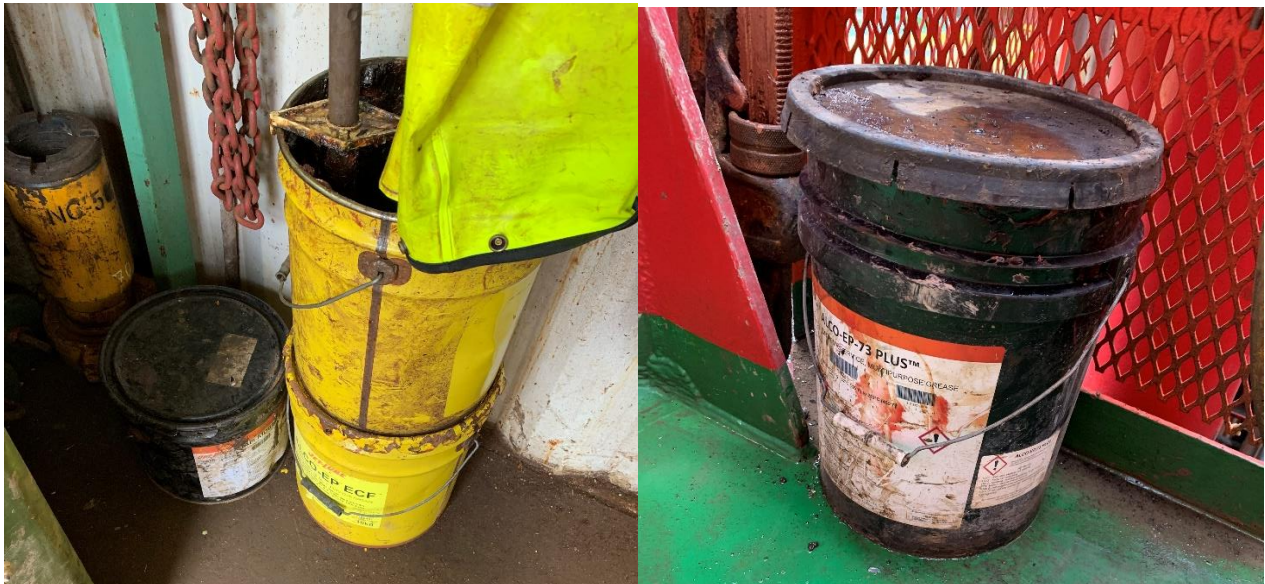
Figure 0-15: Jet-Lube Alco-EP ECF on BOP roof (left) and Jet-Lube Alco EP-73 on drill floor (right)

Jet-Lube Alco-EP ECF were observed in the BOP roof and COSHH-store and Jet-Lube Alco EP-73 Plus was observed in a corner on drill floor (Figure 0-15). Two IBCs with base oil and Erifon CLS 6C were stored outside Storekeeper office, Figure 0-16 and Figure 0-17. Use of these products have not been applied for under the Schweinsteiger operation and must therefore be removed or put in quarantine before start-up. No one could confirm if the IBC where planned backloaded or not. If the Jet-lube products are put in quarantine they must be clearly marked and stored separately from the commonly used chemicals. The IBCs must be removed.

Classification:	Non-Conformance # 2
Description:	Non-applied chemicals onboard
Evidence:	Jet-Lube products, Erifon CLS 6C and Base oil observed
Requirement:	Application for Discharge for the Schweinsteiger well
Risk classification:	Medium

It is recommended that Dolphin implement a routine to check chemical areas after each operation to avoid chemicals from different operators and service companies to stay onboard the rig.

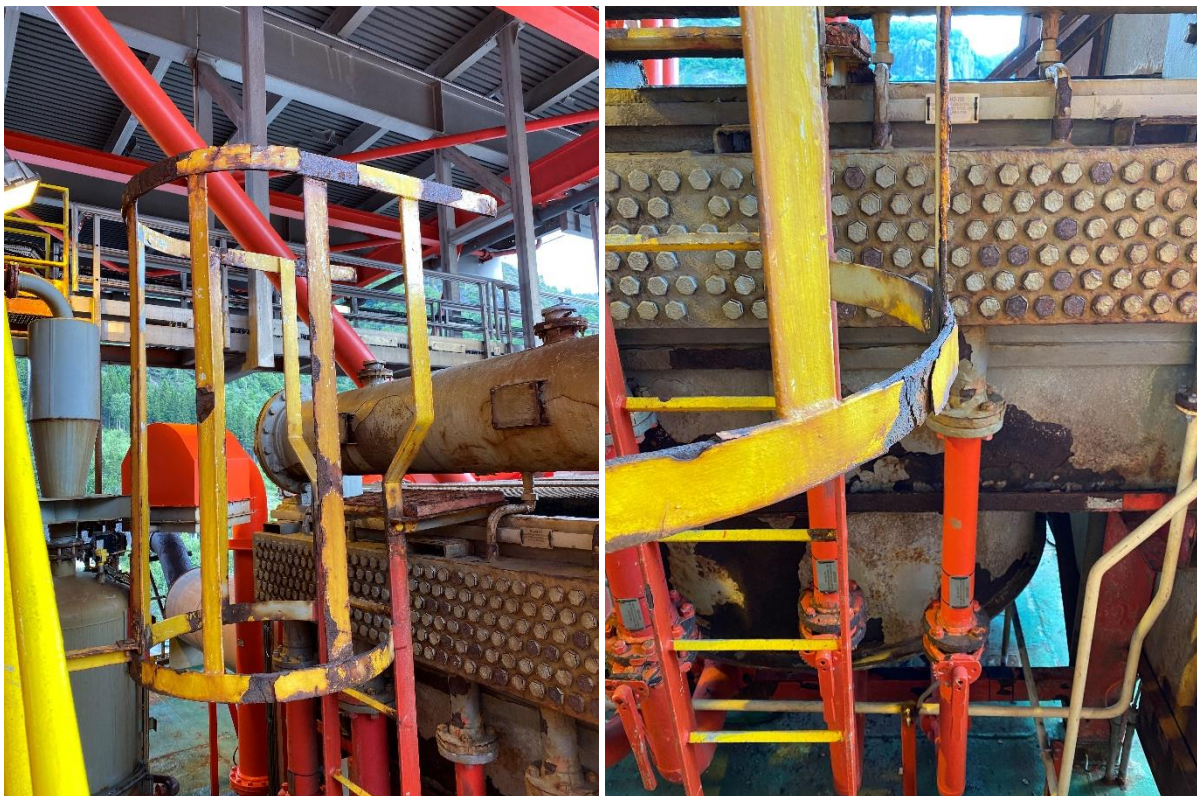
Figure 0-18: Safety cage on ladder could use some maintenance

Classification:	Observation # 15
Title:	Safety cage on ladder outside hospital on port side in poor condition
Risk classification:	Medium
Description:	In order to prevent dropped objects (steel pieces) falling off the safety cage on ladder maintenance is required.

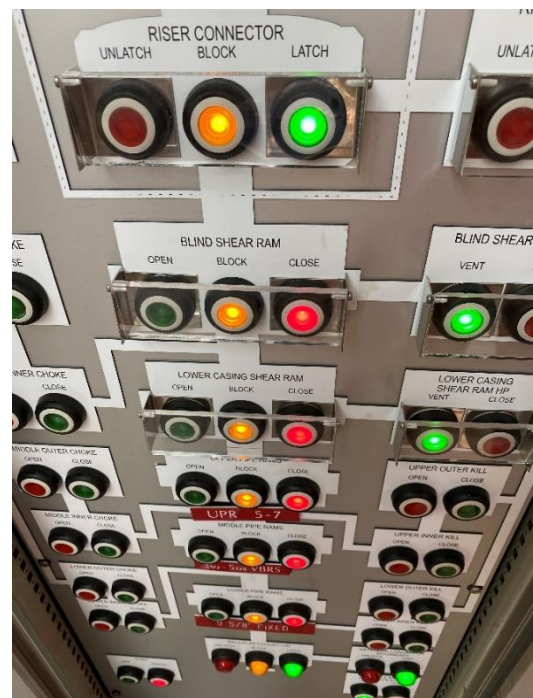
Figure 0-21: Mud mixing & high-pressure mud system schematics (left) and BOP Control panel (right)

On rig floor up to date plasticized schematics showing standpipe, choke and cement manifold line-ups were in place, Figure 0-20. This will assist the crews with "walking the line". A check was also performed to see if the choke control panel had all gauges labelled. This was found OK, but since Wellesley are going to use two

sets of BSR's it is important to follow up that the "Lower casing Shear Ram" label, is replaced by "Lower BSR" on the BOP control panel.

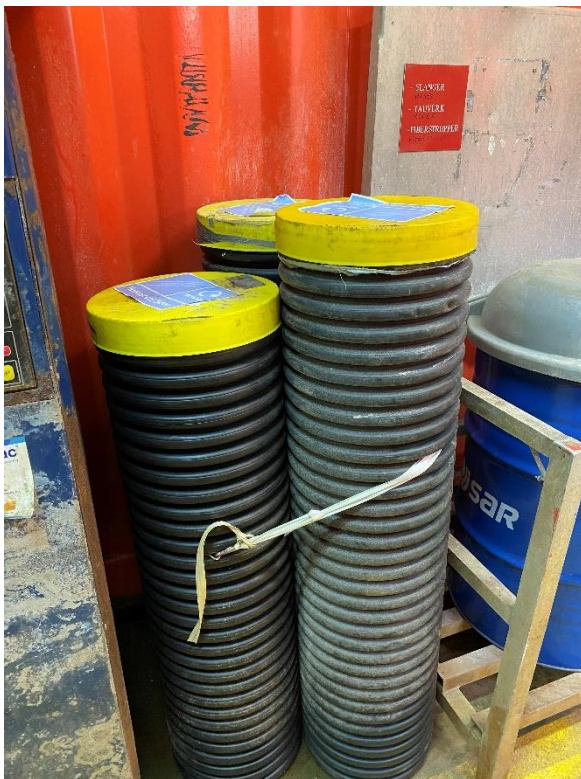
Figure 0-23: Waste bins for handling fluorescent light tubes

The rig intake team did not get any impression that there is any issue with lighting on the rig. This specific question was asked to the crane driver and he did not have any issues. One thing that was noted is that on Borgland LED light fixtures are not being used yet. Instead it is the old fashion lighting fixtures that tends to cause more waste. Having that said the rig intake team was impressed with the way Dolphin handled fluorescent light tubes when considered waste, Figure 0-23.

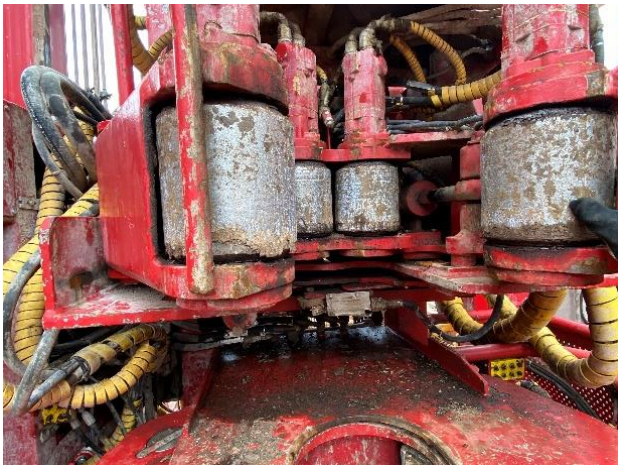
Figure 0-24: Worn rollers on Iron Roughneck

Classification:	Observation # 19
Title:	Rollers on Iron Roughneck are significantly worn
Risk classification:	High
Description:	In order to prevent downtime and potential damage to tubulars, the rollers on the iron roughneck should be replaced.

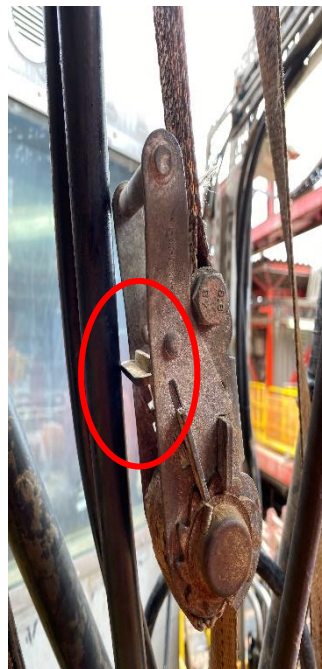
Figure 0-26: Hose securing are "homemade"

Classification:	Observation # 17
Title:	Hose securing on rig floor is "home made"

Risk classification:	Medium
Description:	In order to prevent damage to hoses and avoid potential spill and downtime, a more “fit for purpose” solution should be used.

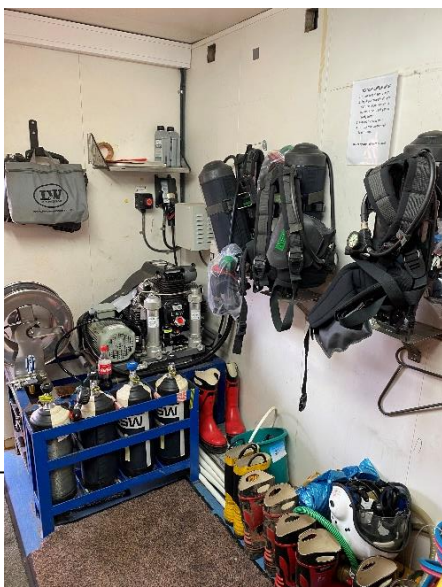
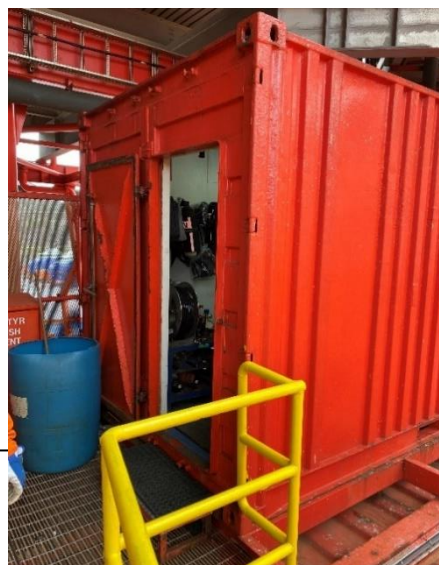
Figure 0-27: Fire station #1

A spot check on the fire stations revealed no major issues. Inventory lists are in place and correct, and fire equipment are nicely stored. Ample amount of breathing air bottles is available. One thing to point out is that in the main fire station (station #1) clothing can be positioned so that it is easy to put on in an emergency case (Figure 0-27). Rig Intake team also suggests that a sign is put on the side of fire station #1 to make it easier to spot (Figure 0-27), that a lock arrangement is put in place on the fire cabinet outside station #1 and that Dolphin looks into a more permanent and suitable solution to store the fire safety plans (Figure 0-28).

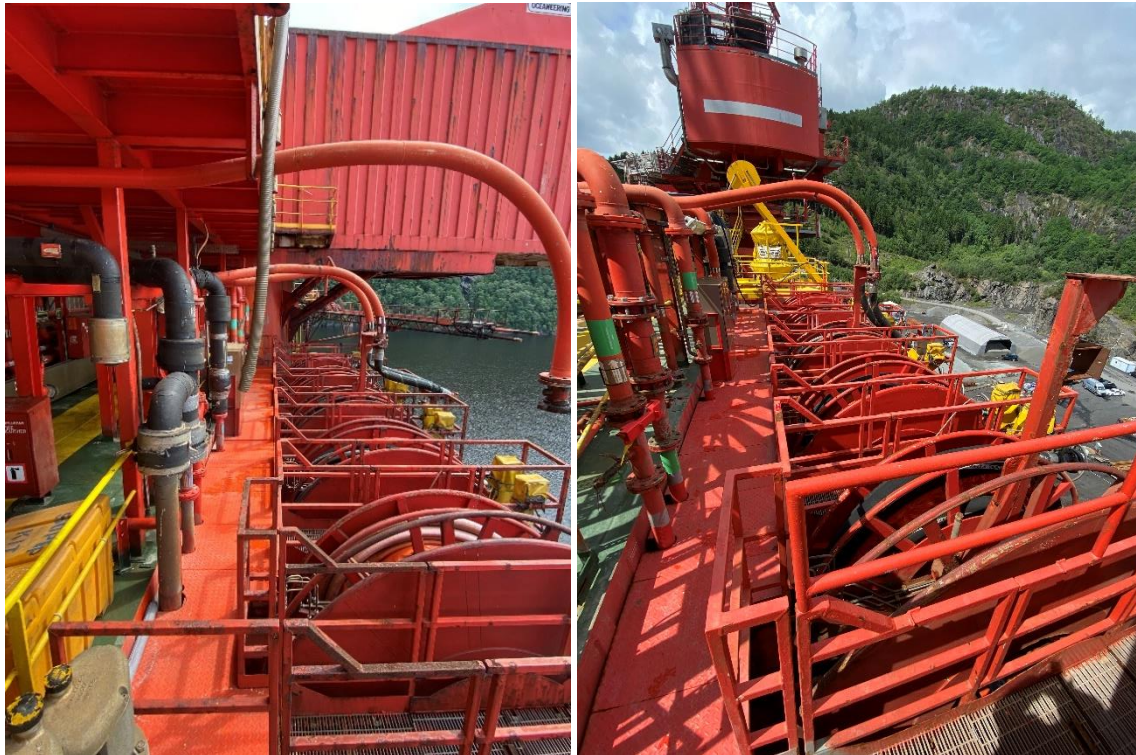
Figure 0-29: Loading stations Starboard and Port

Loading stations and bulk hoses were inspected during the rig visit (Figure 0-29). Equipment appears to be in very good condition apart from a damage that was discovered on the cement bulk hose on the port loading station, see Figure 0-30. All hoses for fuel have a weak link and shut off system in case of a leak or overpull on the hose. Procedures related to bulk transfer are in place and being utilized.

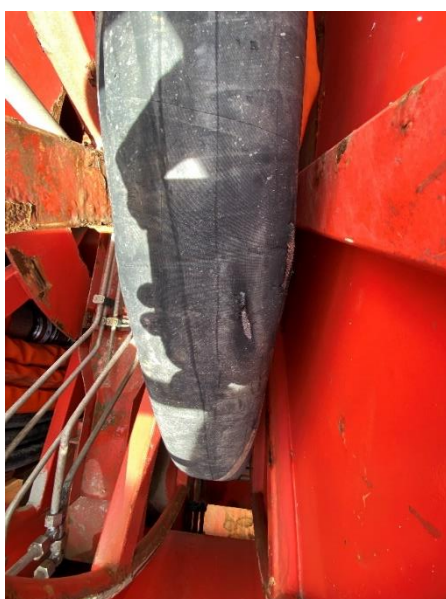
Figure 0-30: Port loading stations with damage on cement bulk hose

Classification:	Observation # 25
Title:	Bulk hose on port loading station
Risk classification:	Medium
Description:	Damage on cement bulk hose on port loading station

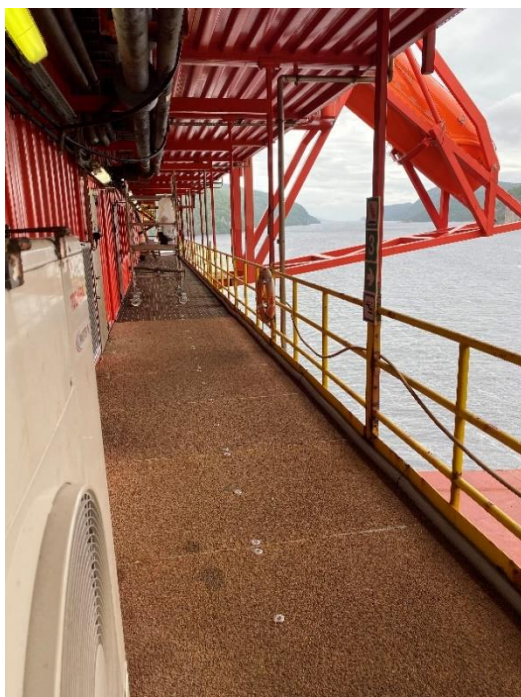
Figure 0-31: Escape ways missing yellow colour

During rig visit a spot check of the escape routes outside on the rig was performed and mostly found OK. However, it was discovered that aft escapeway was missing yellow colour on the gangway, see Figure 0-31,. Dolphin was informed and this will be followed up during next rig visit. It was also checked if there would be any objects falling over escape routes in the event the rig would be tilted. Nothing was alarming but the area outside Storekeeper could be tidied up and sea fastened better, Figure 0-32.

Classification:	Non-Conformance # 3
Description:	Escape ways
Evidence:	Aft escapeway was missing yellow colour on the gangway.
Requirement:	Framework regulations § 3 on the use of maritime requirements, cf. SDir 859/87 VMS regulations § 15 on marking, warning signs and notices, SDir 90/16 rescue regulations § 8 on marking of evacuation routes
Risk classification:	High

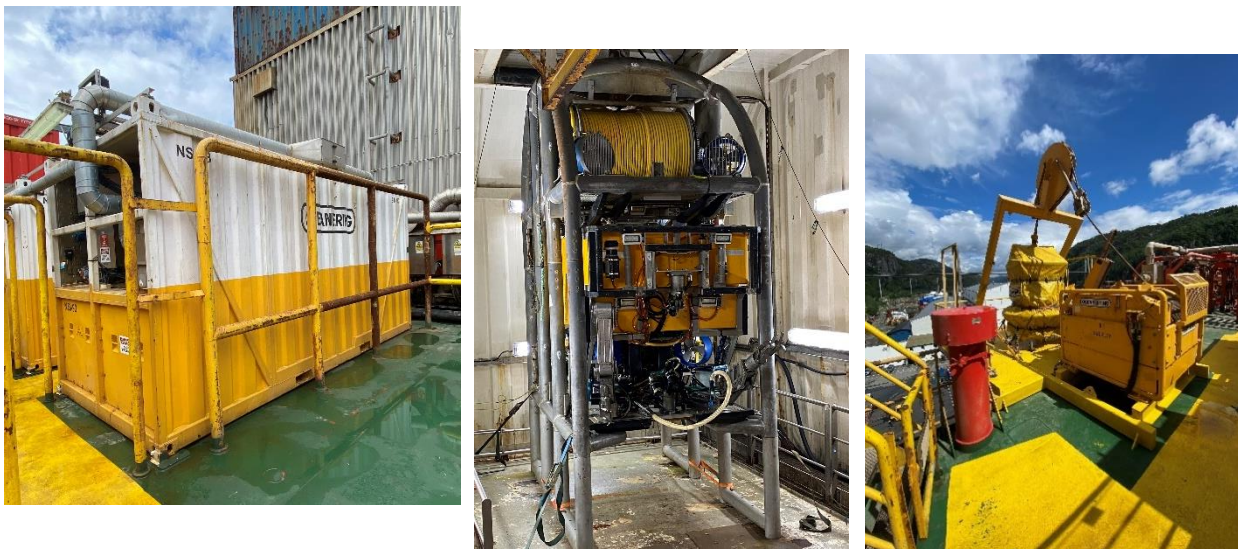
Figure 0-33: ROV unit with WROV and Sea Owl

Borgland is equipped with a Sea Owl in addition to a WorkROV (Figure 0-33).

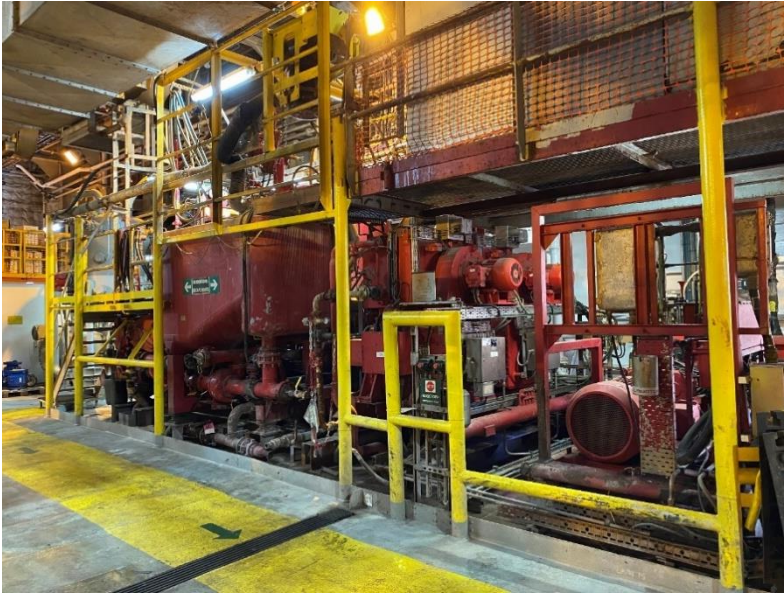
Figure 0-34: Cement unit

Borgland is equipped with a Halliburton cement unit (Figure 0-34).

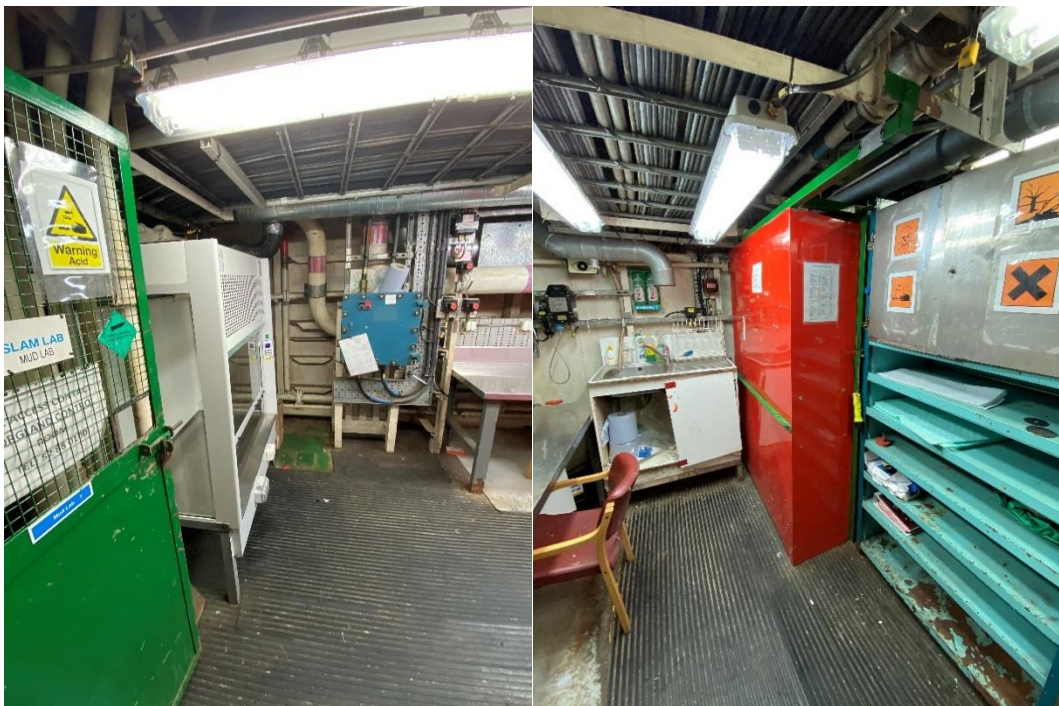
Figure 0-36: Mud Lab

The mud lab was also inspected. As no work was ongoing, it appeared very clean and tidy, see Figure 0-36.

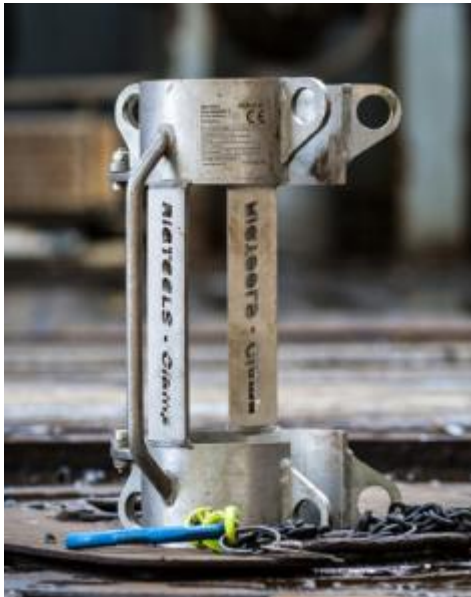
Figure 0-39: Lifting Clamp

Personnel mentioned that they use a lifting clamp (Figure 0-39) from Rig tools when handling lifting subs, but they were unsure if they have received an Safety Alert from the supplier. The lifting clamp could not be spotted onboard. It was also unclear if the clamp is part of yearly inspection in the maintenance system.

Classification:	Observation # 28
Title:	Lifting clamp from Rig Tools
Risk classification:	Low

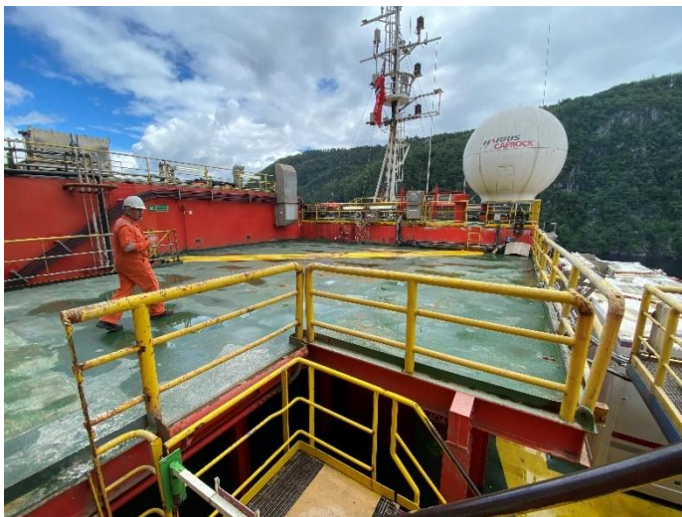
Figure 0-44: Wireline unit area

Wellesley are going to use Schlumberger for the wireline work. At the time of the rig visit/verification the Wireline unit was not on the rig. This will have to be checked prior to rig handover. Schlumberger are planning to perform a rig survey. This needs to be followed up.
